Investigation of Standing Water and Wetland SSSIs thought to be under Diffuse Pollution Pressure: Mill Dam

Commissioned Report No. 730

Contractor: EnviroCentre Ltd.

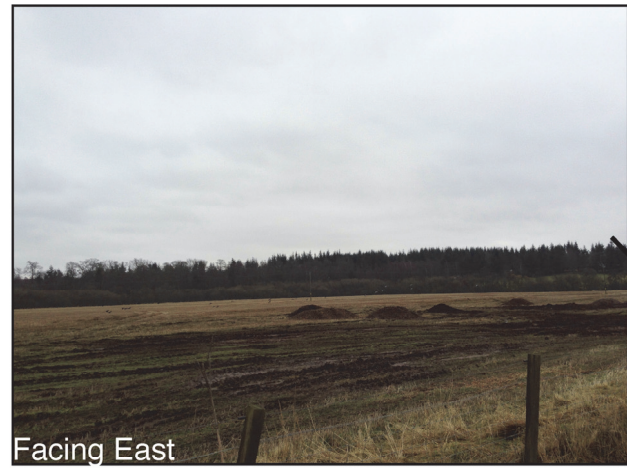
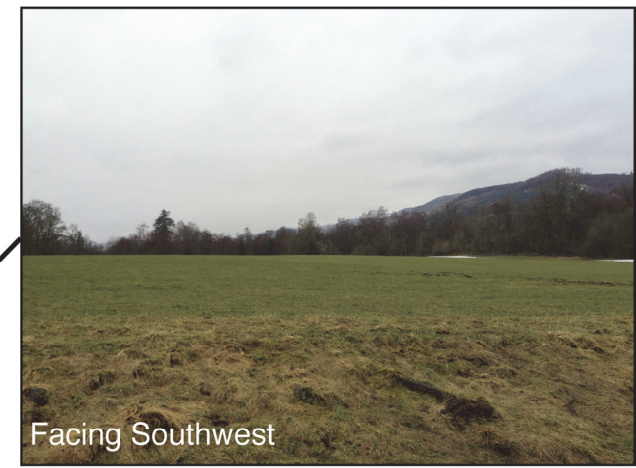
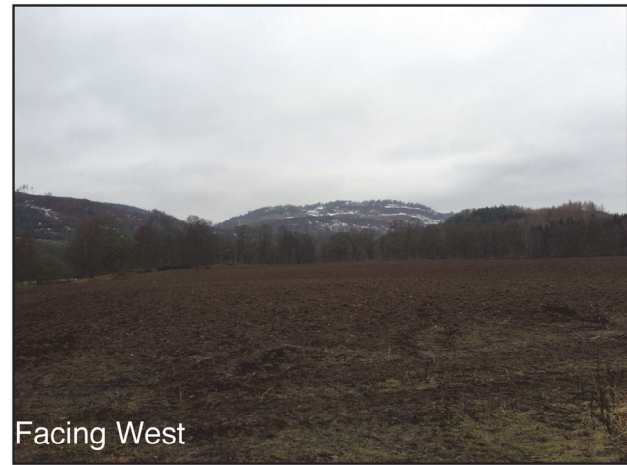
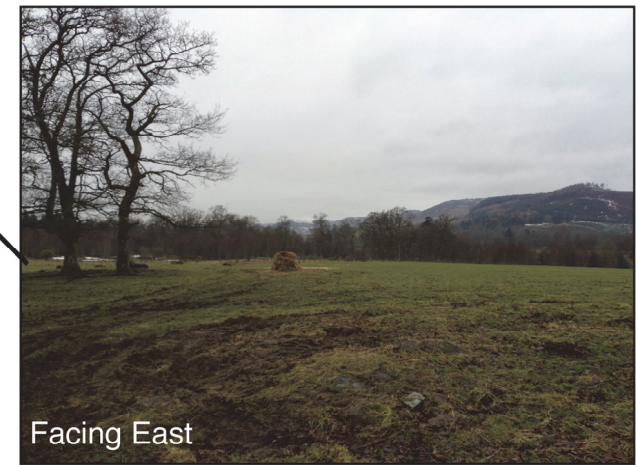
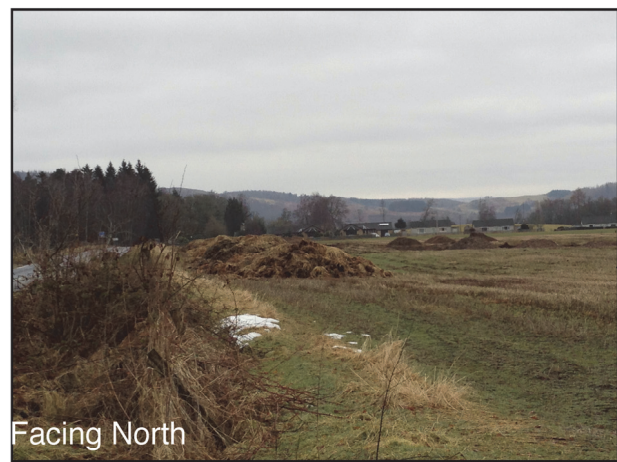
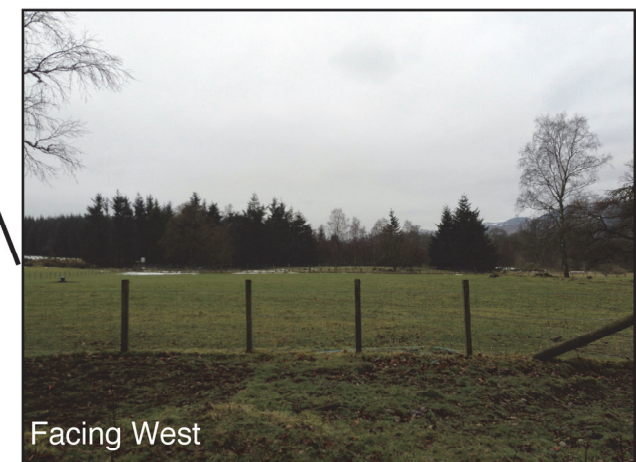
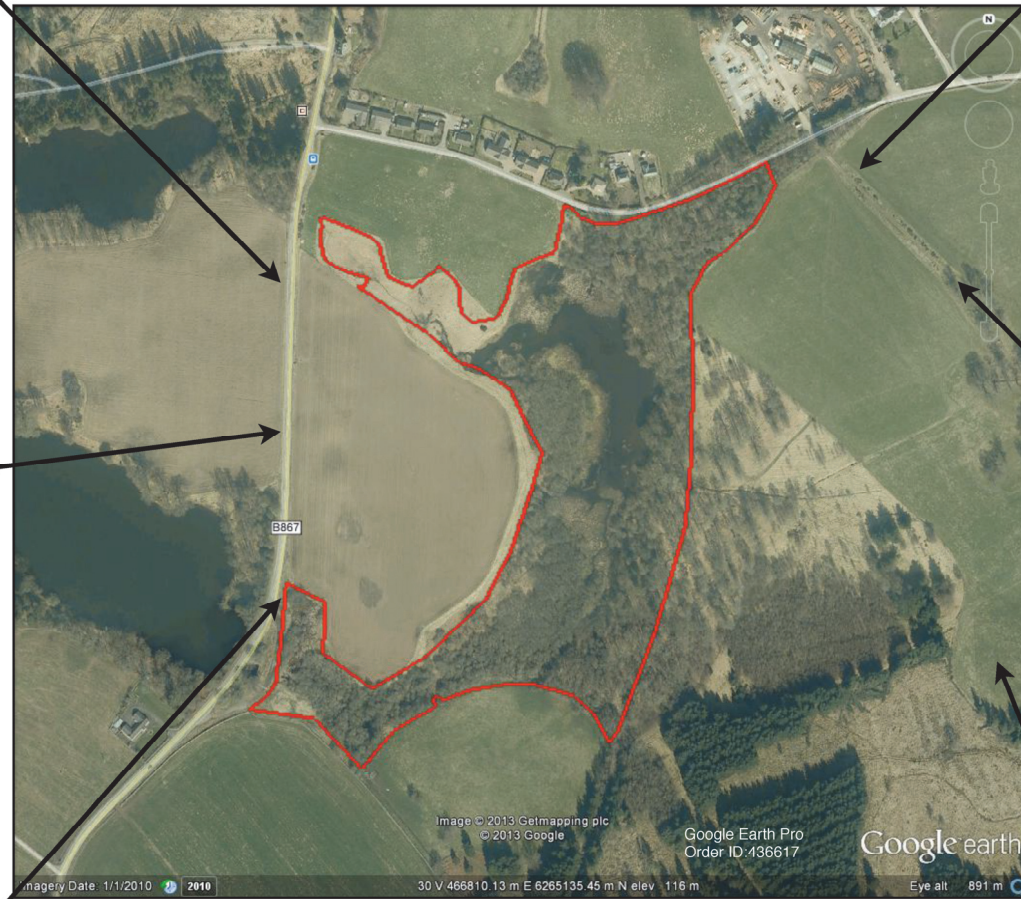
Figure 2.4: Surrounding Land Use Photographs

Photograph Log- Surrounding Catchment
Photographs Taken 20th February 2013
